NATIONAL DAM SAFETY PROGRAM. SALISBURY MILLS DAM, INVENTORY NUM--ETC(U)

| REPORT DOCUMENTATION PAGE | | READ INSTRUCTIONS<br>BEFORE COMPLETING FORM |
|--|---|--|
| 4. TITLE (and Subtitle)<br>Phase I Inspection Report<br>Salisbury Mills Dam<br>Moodna Creek Basin, Orange County, New York<br>Inventory No. N.Y. #4 | | 5. TYPE OF REPORT & PERIOD COVERED<br>Phase I Inspection Report<br>National Dam Safety Program |
| 17. DISTRIBUTION STATEMENT<br><br><i>6</i> National Dam Safety Program. Salisbury Mills Dam, Inventory Number 4, <del>XXXX</del> Moodna Creek Basin, Orange County, New York. Phase I Inspection Report | | |

DATE: 19 April 1978

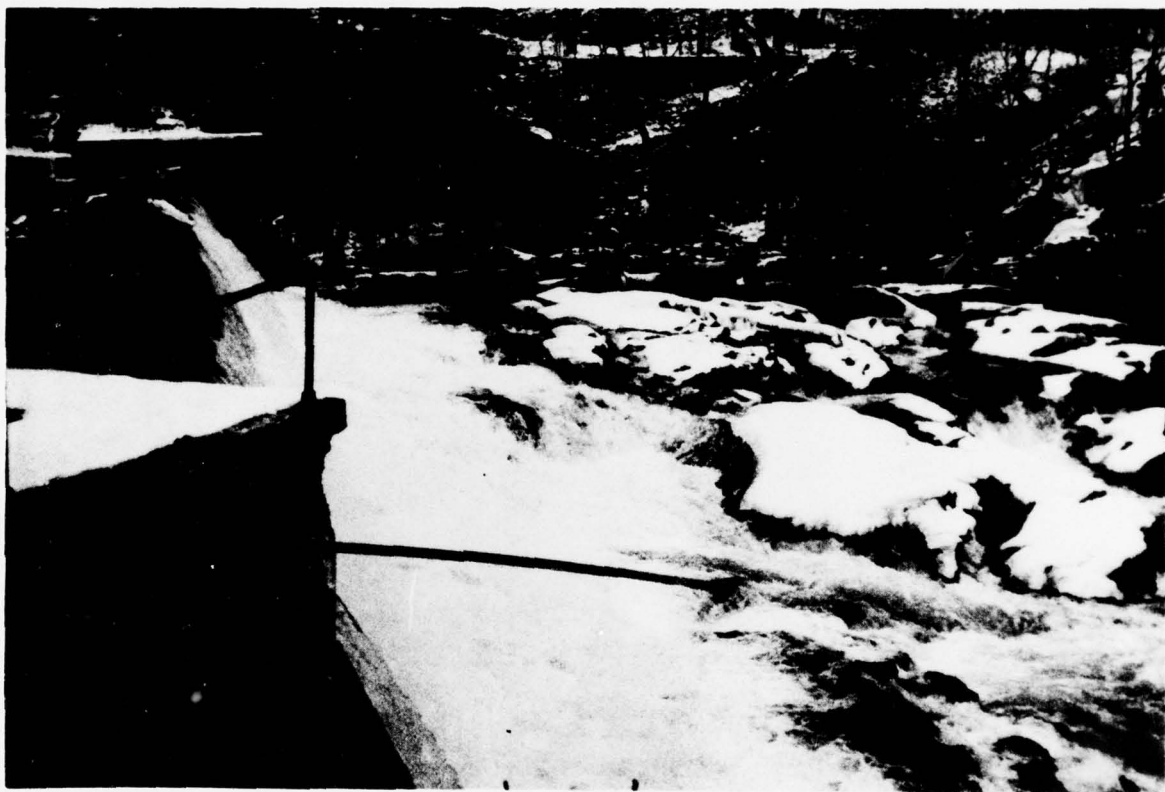
OVERVIEW PHOTO  
SALISBURY MILLS DAM

The Salisbury Mills Dam exhibits serious loss of supportive stone and leakage at the left masonry abutment tie-in wall and serious maintenance deficiencies which render the dam unsafe. The dam will be over-topped by the probable maximum flood or the standard project flood. Although the dam is founded on ledge rock and designed for over-topping the deteriorated condition at the left abutment would cause failure during over-topping. In addition, check of original stability computations indicates instability under conditions of the PMF or SPF. Although flood wave analysis indicates present downstream development would not be affected by a break in the dam, the possibility of serious injury or death to individuals in the downstream flood plain at the time of a break, exists. For this reason it is recommended that the impoundment be lowered immediately and a program of around the clock surveillance be initiated during periods of heavy flow. In addition missing manhole covers and deteriorated timbers on the intake structure should be replaced immediately. If the dam is not repaired, future development in the downstream area should be carefully monitored to assure that it does not fall within the flood plain.
